Biodiversity in western part of the Fethiye Bay

Erdoğan Okuş, Hüsne Altıok*, Ahsen Yüksek, Noyan Yılmaz, Aslı Aslan Yılmaz, S. Ünsal Karhan, Nazlı Demirel, Edip Müftüoğlu, Volkan Demir, Sibel Zeki, Evrim Kalkan and Seyfettin Taş

Institute of Marine Sciences and Management, Istanbul University, Turkey

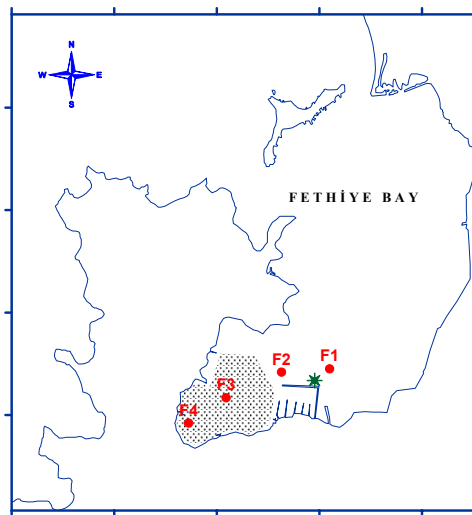
Figure 1. Study region and stations (hydrological stations; circle, ADCP station; star) (dotted region indicates diving zone).

In order to determine the marine biodiversity at the western part of the Fethiye Bay, 15 SCUBA and 3 skin dives were performed in 25-27 February 2006 (Figure 1). The diving program included 4 groups, each consisting of two or three divers, twice a day, one in the morning and one in the afternoon, and most of the time 8 dives were achieved daily. The starting and ending coordinates of each group were determined by GPS. One of the groups carried an underwater video system to document characteristics of the region and to record the components of biodiversity while another group carried a professional digital underwater photography system. The aim of the video recordings and photographs is to document different species, the state of bottom structure, the distribution and condition of the facieses, the

In order to determine quality of the water column hydrographic parameters at four stations (Figure 1) were measured on 25 February 2006. Temperature and salinity data were obtained by using SBE25 Sealogger CTD self contained memory card. The current measurement was realized with 300kHz Work Horse ADCP at depth of 12m shown with star in Figure 1. The current measurements were recorded almost 1 day duration with 1 minute interval between 15:35 Saturday 25th February 2006 and 21:30 Sunday 26th February 2006. The average data was taken as ensemble 5 minutes after taking off bad data.

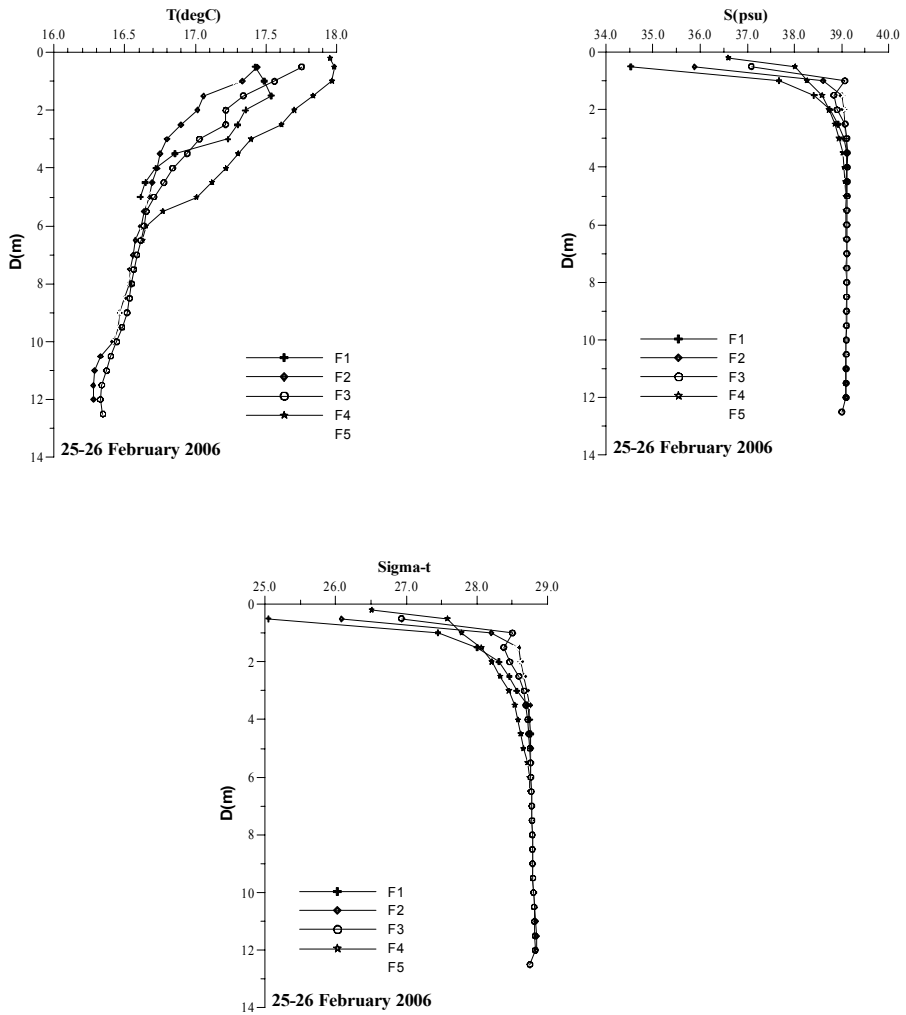
The temperature and salinity profiles indicate that there is a thin surface layer in the studied region (Figure 2). Salinity of the surface water is relatively low. The surface temperature is in the range of $17.4\text{--}18.0^{\circ}\text{C}$ and salinity is in the range of 34.5-39psu. The temperature decreases suddenly before 4 m depth and then slowly decreases to 16.2°C . The salinity is almost the same (39psu) below 1-2m depth. Surface temperature decreases from inner part of the Bay (station F4) to the outer part of the Bay (station F1).

Figure 2. Temperature, salinity and sigma-t profiles

The reason of this is that the atmospheric heat affects the water column in the inner part of the region which is shallower and protected. It is observed that the salinity in outer part (station F1) is lower than that of in the inner part (station F4). This indicates that the cold and fresh water which is considered to be coming from the canals in east part of the bay is more effective at the station F1.

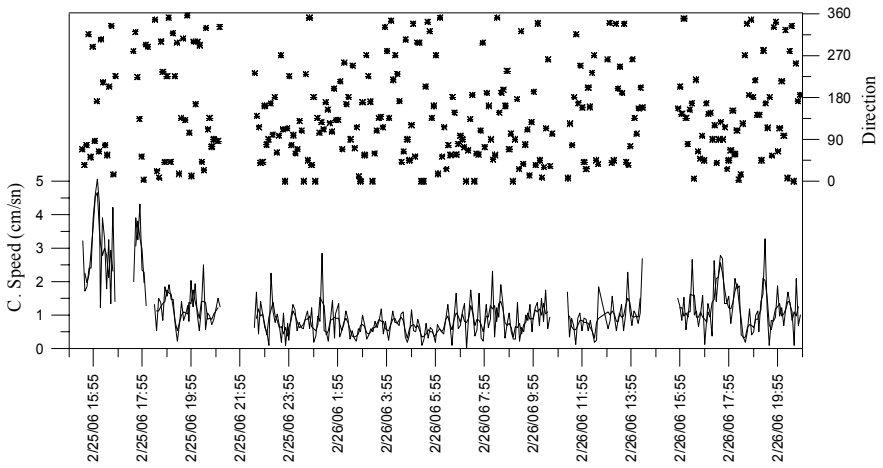
The current speed does not vary along the vertical distribution. For this reason, the current values at 5m depth are chosen to represent the water column current velocity. As it can be seen from the time series of the current speed and direction given in Figure 3, there is a weak current in the bay. The current direction during the first two hours was towards northeastern and its speed was about 3.5cm/sec. After these two hours, while the current speed was slower (nearly 1cm/sec) with small fluctuation, current direction was generally towards east but not stable. Progressive current velocity diagram (Figure 4) indicates that current was in the northeast direction at the beginning of the observation, later on, it directed towards northwest and north, and then between 22:00 and the end of the observation, the current direction was mostly toward east. Total movement was rather short since the current speed was small and the current direction changed frequently.

Figure 3. Time series of the current speed and directions

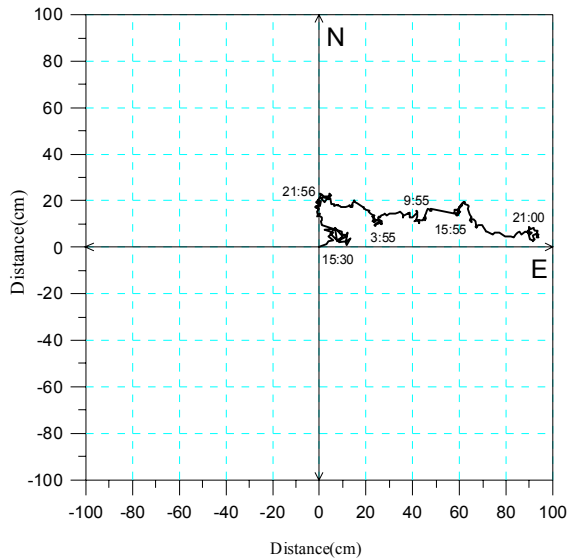
Figure 4. Progressive current velocity vectors

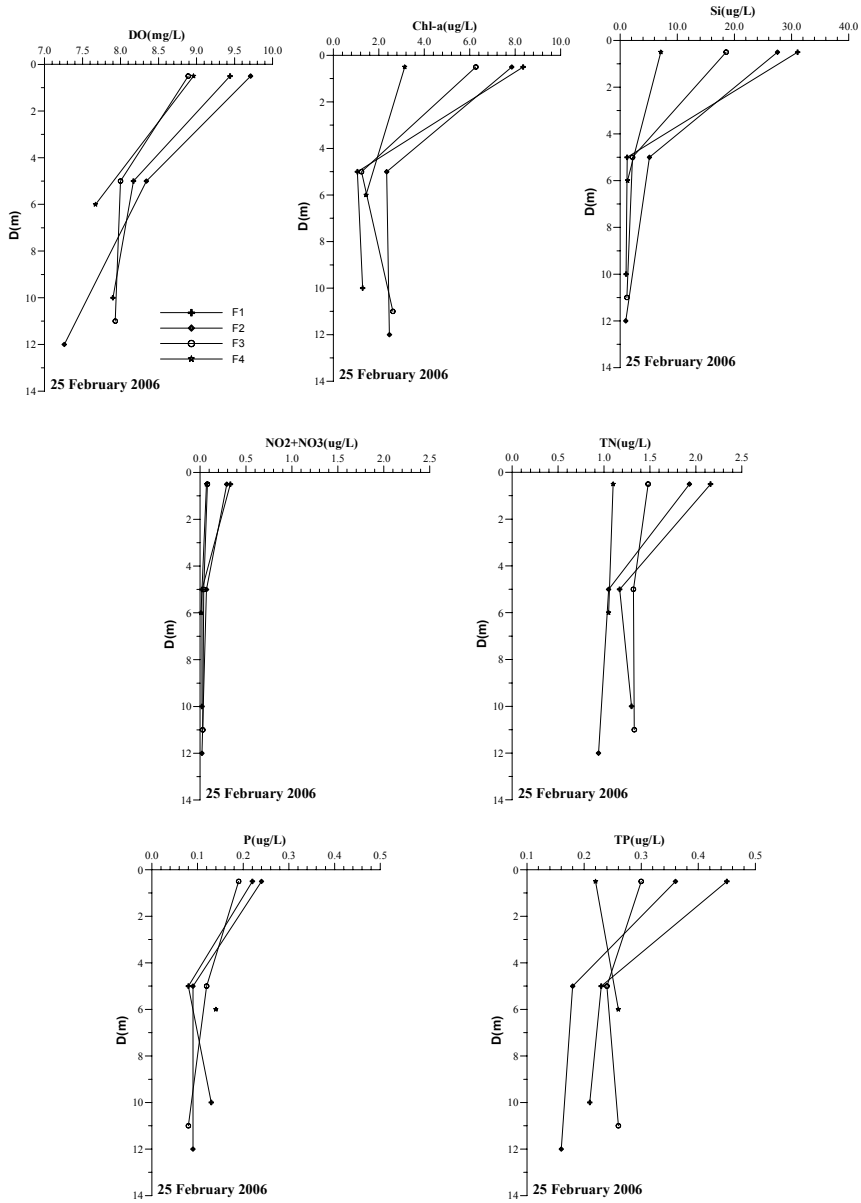
Figure 5. Dissolved oxygen and nutrients profiles.

The distribution of the nutrient in the bay (Figure 6 and Table 2) shows that nutrient values represent the winter conditions in general. Nitrate + nitrit

values are in the range of 0.01-0.33 μM . The maximum values are observed in the surface water, suggesting that fresh water rich in nutrient inputs from the canals to the bay. The other point is decrease of the nutrient values along the outer (station F1) to inner (station F4) part of the bay. A similar distribution is observed for total nitrogen, silicate and phosphate values. Especially silicate distribution obviously shows that the maximum values were found in surface water and higher values were in outer part of the region. Due to weak currents, suspended matter is resident in water column.

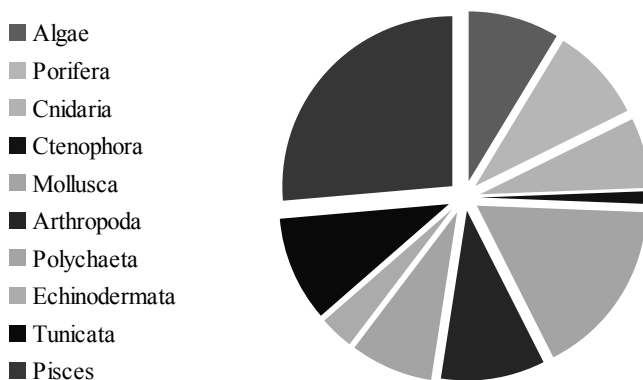
A total of 118 species belonging to 10 taxonomic groups are detected in the study area (Table 4, Figure 6). The most diverse group is fishes with a ratio of 26%. The distribution of fishes is generally round and beneath the pontoons. The second important group is Mollusca (17%) and they are also more diversified around pontoons. On the other *Hexaplex trunculus*, a detritus feeder is densely distributed on the silt bottom. Other important groups are Tunicata and Arthropoda. The list of species identified is given in Table 5.

Figure 6. Pie diagram of the taxonomic groups.
